# LOUISIANA DEPARTMENT OF WILDLIFE & FISHERIES

WATERBODY MANAGEMENT PLAN SERIES

### **HENDERSON LAKE**

LAKE HISTORY & MANAGEMENT ISSUES

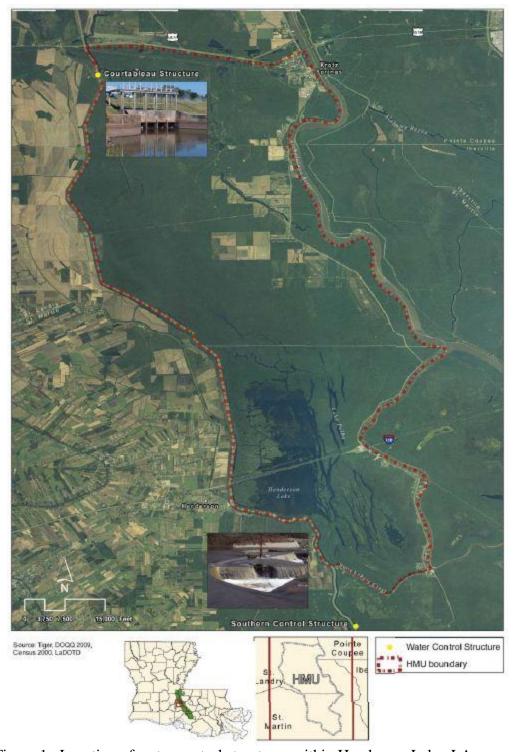
Figure 1. Location of water control structures within Henderson Lake, LA.

The southern control structure is located in St. Martin Parish, south of Henderson Lake in the borrow canal adjacent to the West Atchafalaya Basin Protection Levee (WABPL). The drawdown structure is a gated system that can be opened to allow ingress and egress of boat traffic and can be used to dewater the lake (See map of structure locations, Figure 1).

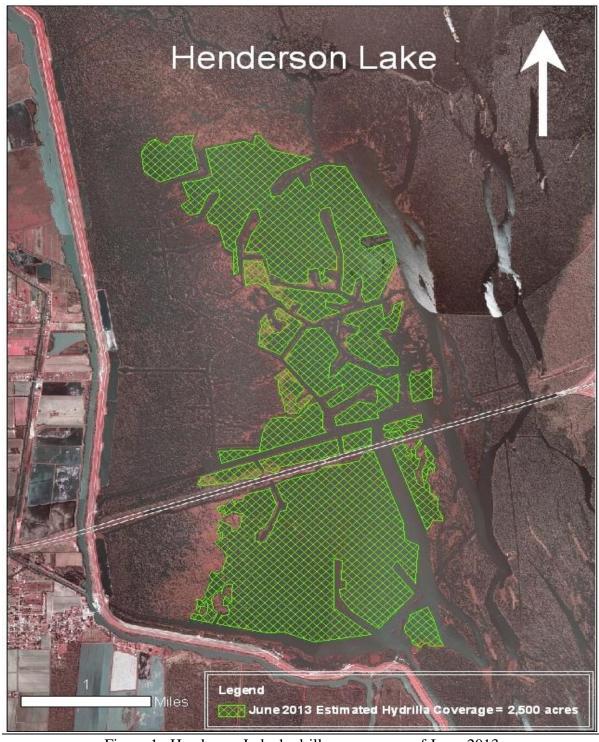
Figure 1. Henderson Lake hydrilla coverage as of June, 2013

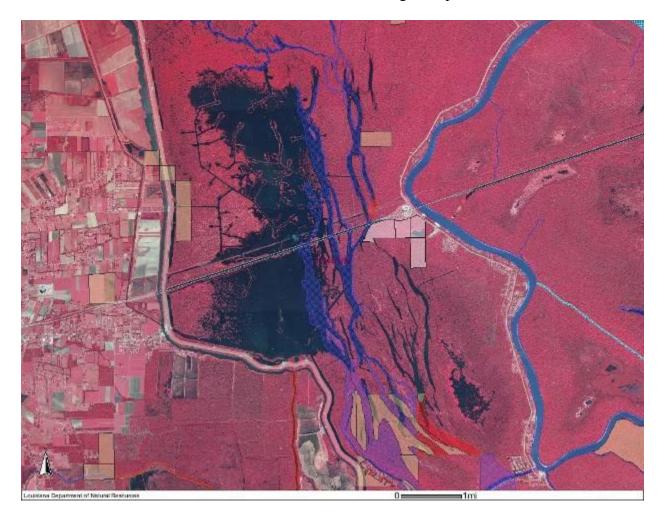
Appendix III
(Click here to return)

## Map of State Water-bottoms in Henderson Lake. State water-bottoms in blue and state lands in orange and pink outlined in black.

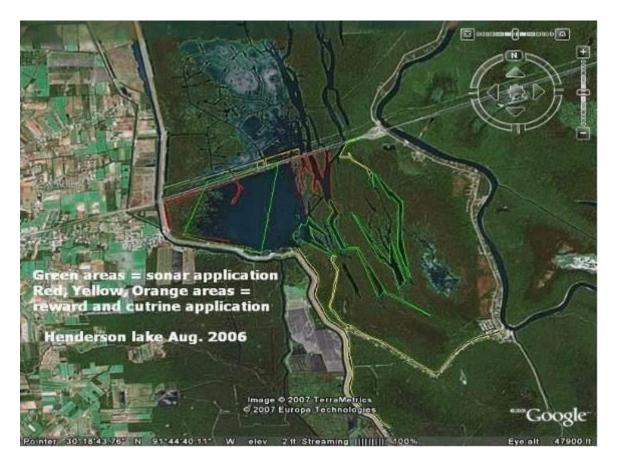
Henderson Lake, St. Martin parish, recently (8/28/06) was treated using SONAR to control the heavy infestation of Hydrilla south of interstate 10. Water levels in the lake were lowered two feet below pool stage to allow for adequate control; pool stage is 9.0 ft. (MSL).

Moderate amounts of common salvinia (*Salvinia minima*), coontail (*Ceratophyllum demersum*) and duckweed (*Lemna minor*) were found throughout the lake. Other plants that were observed in light to moderate amounts were primroses (*Ludwigia spp.*), sedge (*Carex spp.*), smartweed (*Polygonum hydropiperoides*), flatsedge (*Cyperus spp.*), and filamentous algae (*Pithophora spp.*) North of interstate 10 a heavy infestation of hydrilla and water hyacinth is present. This includes the north flats, Phillip canal, Coquille Bay and Fordoche Lake and bayou. These areas are Corps owned and were not treated.
